# RETUBING OF TOMATO PROCESSING BOILER MAINTAINS HARVEST SCHEDULE

## BOILER CASE STUDY

### J.G. Boswell Tomato Company

Boiler Retubing

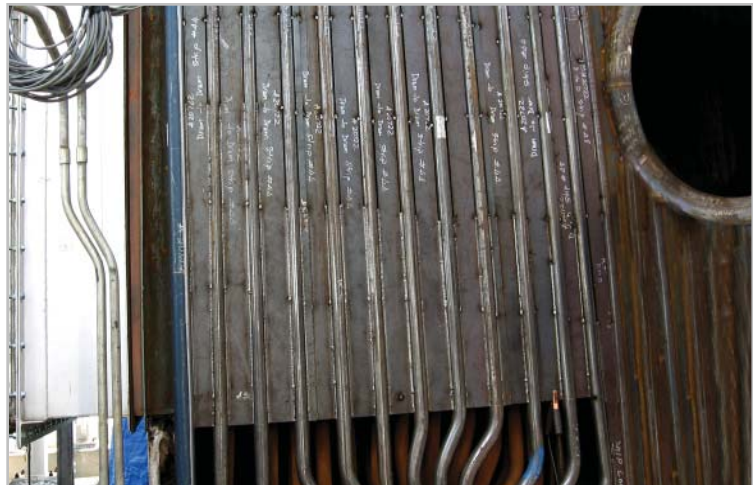
The completed section of tube replacement for the boiler front wall

Before technicians begin tearing out the old tubes, the root cause of the corrosion must be identified and corrected to prevent further degradation. Once the root problem has been isolated and solved, a single tube is removed from the drum and used as a template for bending the replacement tubes into the correct shape. After the tubes have been properly molded, the membranes are welded on and the new tubes are ready for installation. In the J.G. Boswell case, over 100 tubes were replaced, each one carefully inspected to ensure the proper safety and functionality of the boiler.

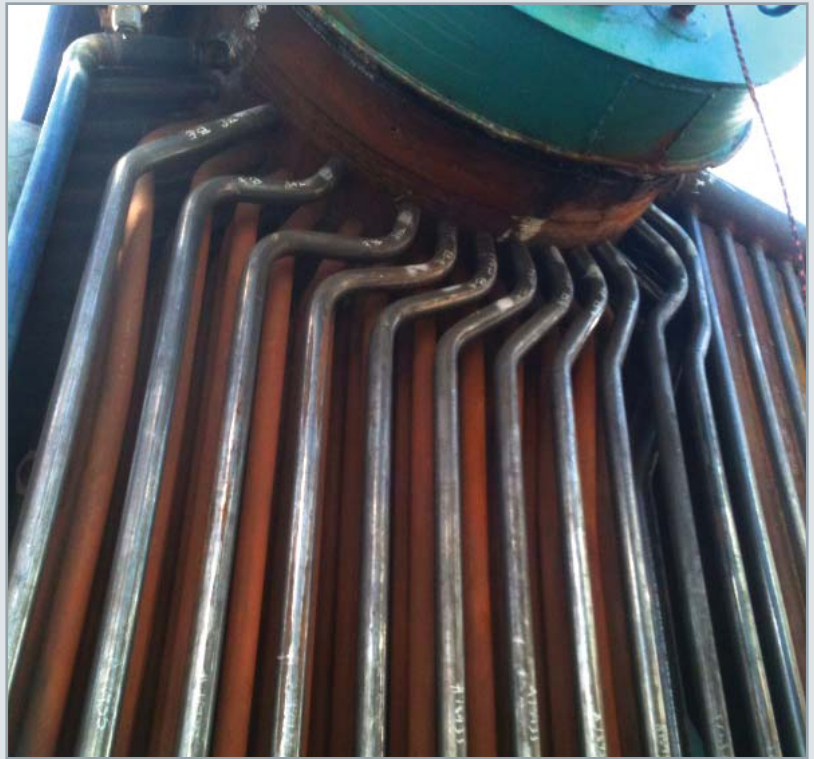
New outside tube sections moulded, welded and installed in the existing boiler

In addition to the side wall corrosion problem, routine maintenance had identified an ongoing issue with the refractory walls. As a result R.F. MacDonald Co. recommended an upgrade to convert the refractory wall tubes to a membrane style. This resulted in correcting the long term problem.

New heaters were placed in the siding to evaporate any moisture that gets trapped in the insulation, located outside the boiler tubes. Boilers exposed to constantly shifting cold and hot states are prone to condensation, so R.F. MacDonald Co. has coordinated a service plan to periodically change the insulation padding and prevent condensate build-up from escalating into a serious problem. With the proper care and maintenance, R.F. MacDonald Co. estimates the new boiler water walls will supply years of reliable service.
