INCREASED RELIABILITY AND ACCURACY OF A DOSING PUMP SMOOTHS OVERALL OPERATION

PUMP CASE STUDY

JBT Foodtech

Visalia, California Dosing Pump Installation

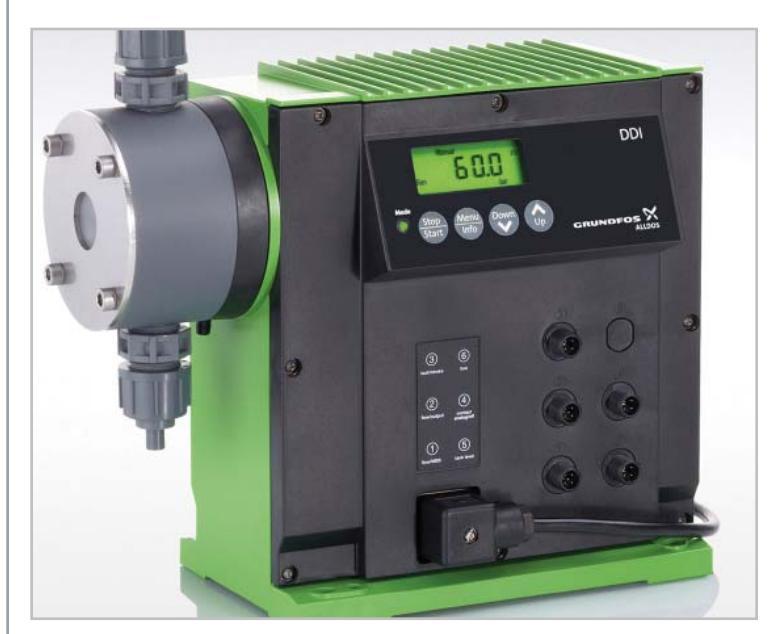
The Grundfos Digital Dosing pumps deliver precise dosing from a single digital interface

Grundfos Digital Dosing pumps use a camshaft to drive the diaphragm, which ensures an optimum mixing ratio of the liquid chemical dose while providing a significant reduction of pressure peaks within the system. This prevents mechanical stress and wear on parts such as the diaphragm, tubing, and connections, resulting in a lowered maintenance requirement.

In addition to increased reliability, Grundfos Digital Dosing pumps are extremely easy to calibrate; requiring only a sample test run. After the results of the test run are entered into the digital control display, the pump automatically corrects itself to the desired output. Competitor dos-

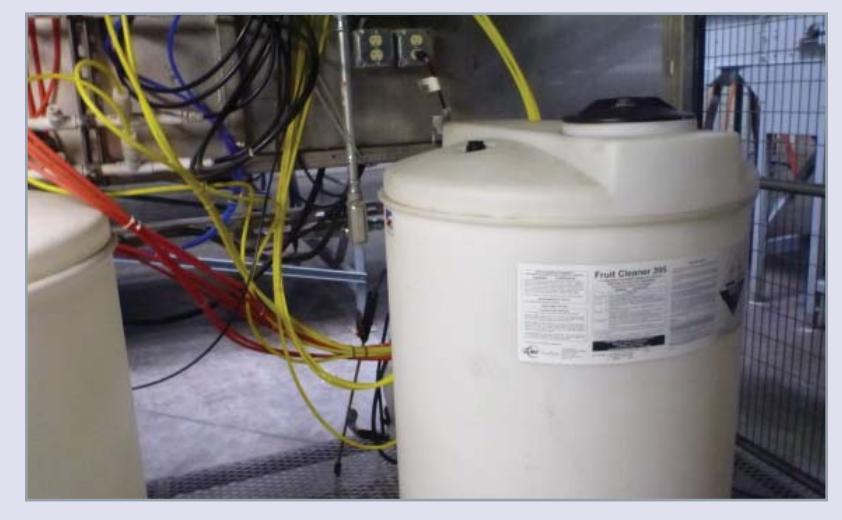
Dosing materials shown here are housed below the cabinet of pumps (top photo) where they can be easily monitored and maintained. Notice the yellow and orange feed tubes that connect to the pumps and can be seen in the previous photo

For this particular application, R.F. MacDonald Co. replaced the plastic ball bearings in the check valves with stainless steel. The heavier bearings cut through the viscosity of the wax much better, enhancing productivity by eliminating pump flow restrictions.
