QUICK REPAIR REQUIRED ON A PUMP USED IN SKI RESORT SNOW MACHINE OPERATIONS

PUMP CASE STUDY

June Mountain Ski Area

June Lake, California
Pump System Repair

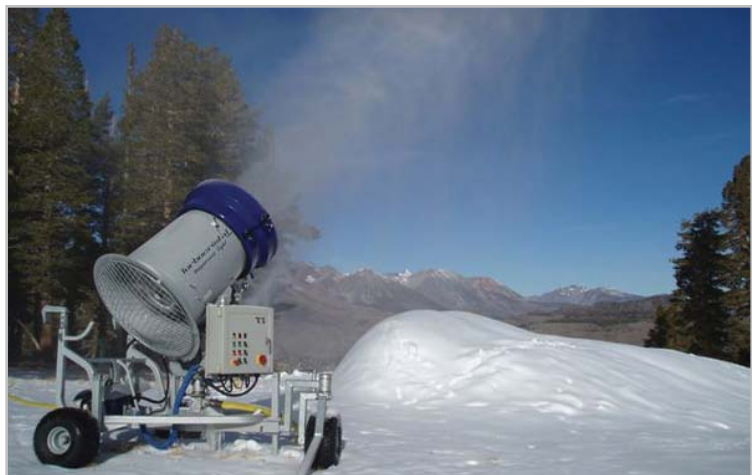
The entire underground and portable snowmaking system is fed by a single pump

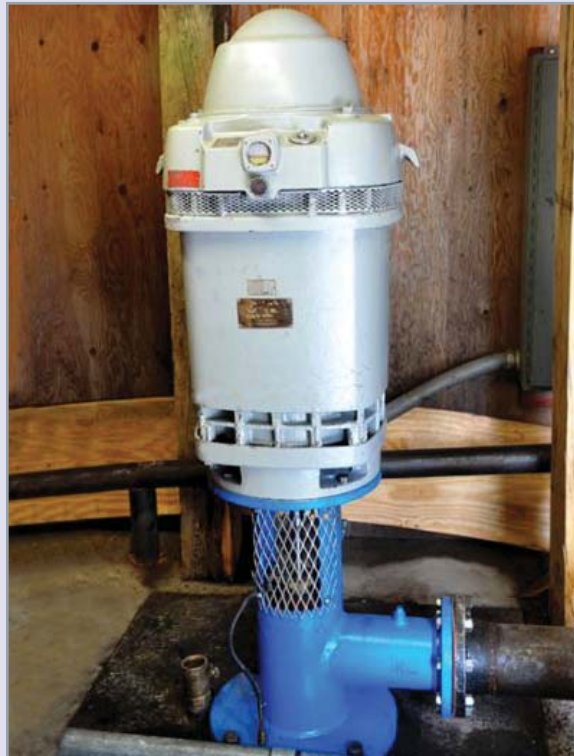
Final installation of the vertical pump

The new pump had slightly different specifications, so a new column pipe had to be constructed. In addition, the motor required rebuilding and new bearings needed to be installed. Even with all the work required the new pump was installed just in time for the ski season. R.F. MacDonald Co. also provided start-up of the unit to ensure everything was operational.
